**High-Speed, High-Temperature Finger Seal
Test Results**

Margaret P. Proctor
NASA Glenn Research Center
Cleveland, OH

**38th AIAA/ASME/SAE/ASEE
Joint Propulsion Conference and Exhibit**
July 7-10, 2002 / Indianapolis, IN

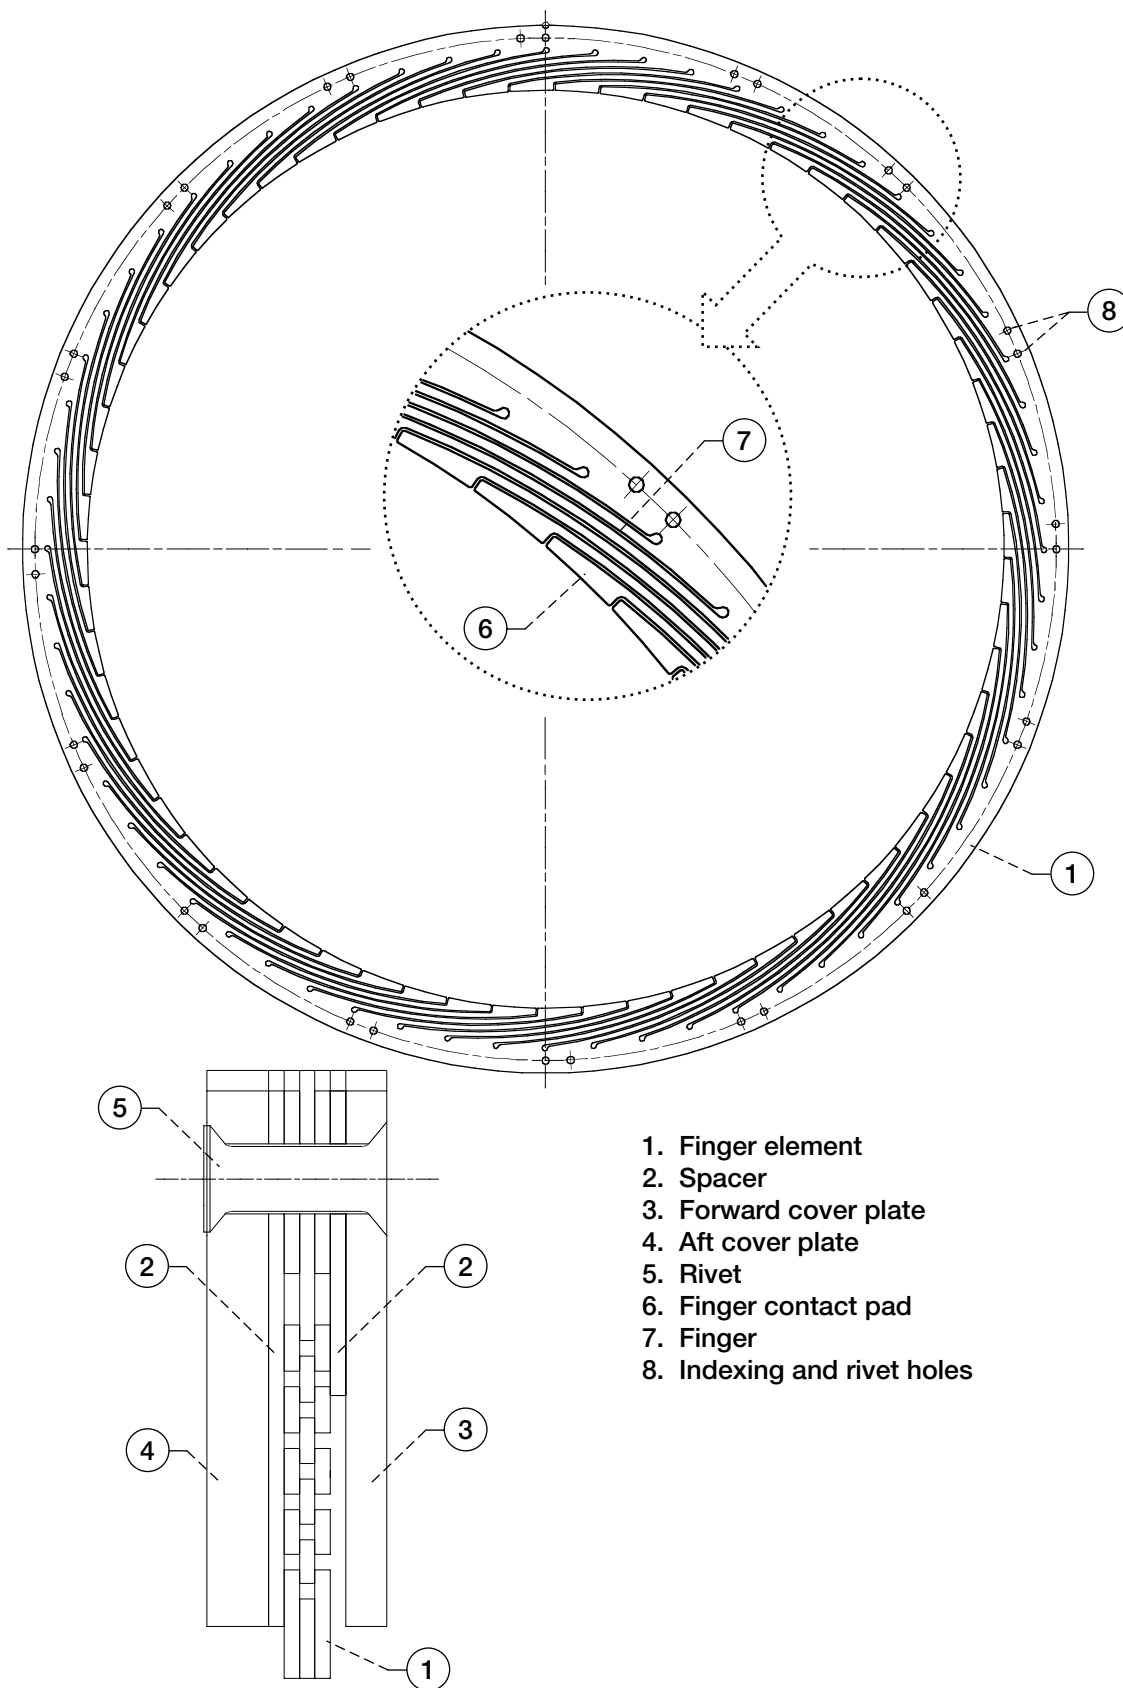
Figure 1.—Finger seal design.

The finger seal is similar in general configuration to a brush seal, but functions in a different manner. Instead of a random array of fine wires, the finger seal uses a stack of tight-tolerance sheet stock elements. Each element is machined to create a series of slender curved beams or *fingers* around the inner diameter (fig. 1). Each of these fingers (7) has an elongated contact pad (6) at its free end. Each element (1) also has a series of assembly hole pairs (8) near its outer diameter. These holes are for the rivets (5) that assemble the seal. The holes are spaced such that when the elements are alternately indexed to the two holes, the spaces between the fingers of one element are covered by the fingers of the adjacent element. Usually a seal is assembled with multiple finger elements (1), forward and aft spacers (2) and forward (3) and aft (4) cover plates. The seal is fitted over the rotating shaft or rotor with a small amount of clearance or interference, depending on the application. The staggered finger/pad features as well as the radial contact between the rotating land and the pads impede airflow through the seal. The flexible fingers can bend radially to accommodate shaft excursions and relative growth of the seal and rotor resulting from rotational forces and thermal mismatch.

A key feature of the finger seal is its low cost of manufacture. The geometric features on the seal laminates are fashioned using wire electric discharge machining, which is extremely cost-effective. Sheet stock of various alloys and thickness required for the seals is readily available. Riveting of the assembly does not require any elaborate tooling or assembly process.

A parametric finite element modeling program and Honeywell proprietary programs were used to optimize the finger seal design. The finger seal tested was sized to run with a slight interference at operating conditions. The finger elements, spacers and side plates are made of sheet AMS5537. This is a cobalt-base alloy that combines good formability and excellent high temperature properties. It displays excellent resistance to the hot corrosive atmospheres encountered in jet engine operations.

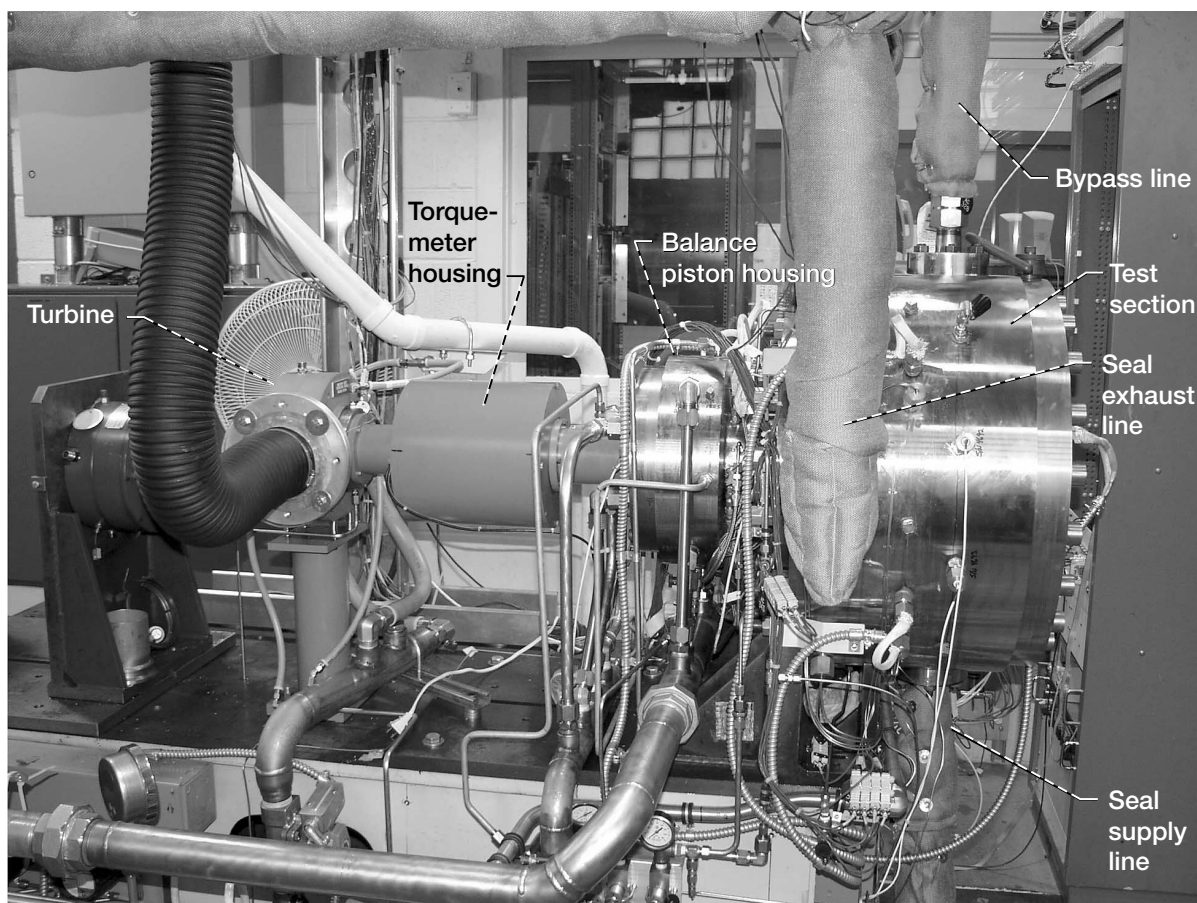
Figure 2.—High-temperature, high-speed turbine seal rig.

Testing was conducted in the NASA High Temperature, High Speed Turbine Seal Test Rig shown in figure 2 and

located at the Glenn Research Center in Cleveland, Ohio. The turbine seal test rig consists of an 8.5-in. diameter test rotor mounted on a shaft in an overhung configuration. The shaft is supported by two oil-lubricated bearings. A balance piston controls the axial thrust load on the bearings due to pressure loads on the test rotor. An air turbine drives the test rig. A torque meter is located between the air turbine and the test rig and is connected to each by quill shafts. The test seal is clamped into the MAR-M-247 seal holder as shown in figure 3. A C-seal located at the seal holder/test seal interface prevents flow from bypassing the test seal at its outer diameter. The seal holder is heated to approximately match the thermal growth of the rotor and prevent a damaging change in radial clearance. Heated, filtered air enters the bottom of the test rig and passes through an inlet plenum that directs the heated air axially toward the seal-rotor interface. The hot air either leaks through the test seal to the seal exhaust line or exits the rig before the test seal through a controlled bypass line at the top of the rig. If seal leakage is low, the bypass line must be open to maintain sufficient flow through the test rig to keep the rig hot.

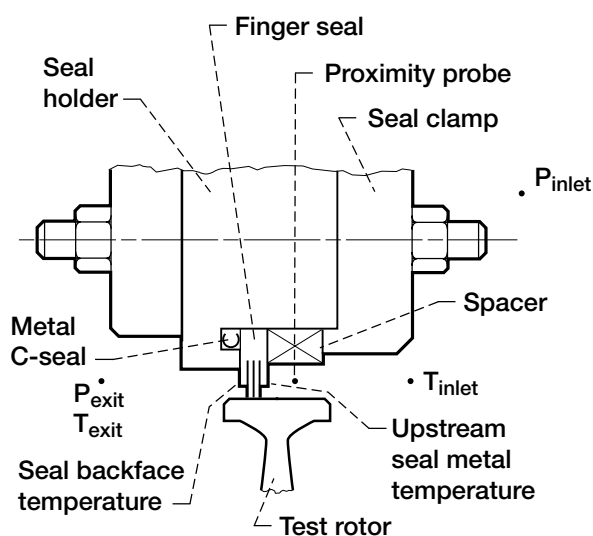
Figure 3.—Test seal configuration and location of research measurements.

Seal inlet and exit temperatures and static pressures, seal upstream metal temperature, and seal backface temperatures were measured at the locations shown in figure 3. For each measurement there were 3 probes equally spaced around the circumference, except for the upstream seal metal temperature for which 2 thermocouples were located at the 90 and 180° positions (0° is top dead center). Type-K thermocouples were used and all were 0.062 in., Inconel sheath, closed ball except the seal exit temperatures, which were 1/8-in. diameter and the seal metal and backface temperatures, which were open-ball.

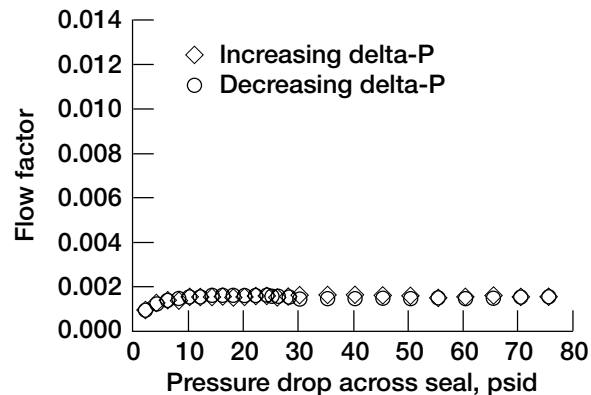
Figure 4.—Static leakage performance of finger seal at average seal inlet air temperature of 1200 °F.

The static performance of the finger seal at an average inlet air temperature of 1200 °F is shown in figure 4 as a plot of flow factor versus pressure drop across the seal. The flow factor increases with pressure drop until about 15 psid and then levels off at a flow factor of approximately 0.0015. At this point the flow is choked.

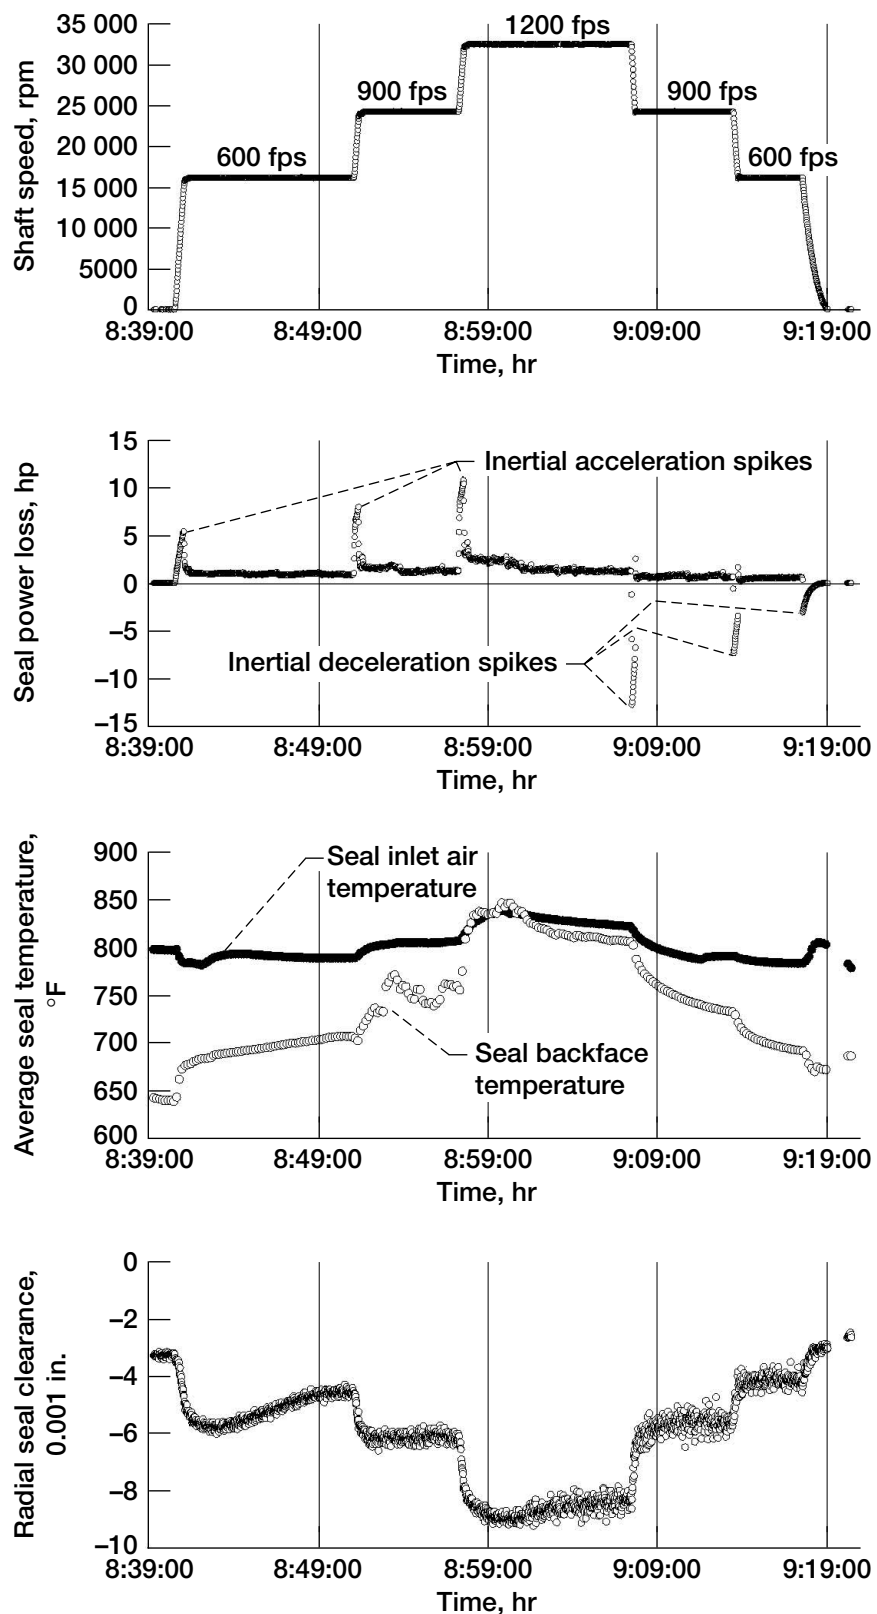
Figure 5.—Time history of initial rotation at 800 °F average seal inlet air temperature and 10 psid pressure drop across seal.

Initial Rotation. The finger seal was tested at 800 °F average inlet air temperature and 10 psid across the seal. Data were recorded once a second while the speed was stepped up to obtain 600, 900, and 1200 fps surface velocities and then stepped back down to 900, 600, and 0 fps. Figure 5 shows a time history plot of shaft speed, seal power loss, average seal backface and inlet air temperatures, and radial seal clearance for this initial rotation. The seal power loss shown is the total power minus the steady-state tare power. The positive and negative spikes as each speed level is attained are largely due to acceleration and deceleration inertia. Note that at 1200 fps the steady state seal power loss declines as time at condition increases. This could indicate wearing of the seal. At steady-state conditions the seal power loss did not exceed 2.8 hp. Frictional heating due to seal-to-rotor contact and wearing is also evident in the average seal backface and inlet air temperatures time history. As speed is decreased, both the seal power loss and average seal backface temperature levels are lower than during the speed increase, which might indicate that wear has occurred. The centrifugal growth of the rotor can be seen in the time history of the radial seal clearance. The radial clearance shown in figure 5 is the change in the distance between the seal holder and the rotor from ambient, static conditions, plus the initial clearance between the seal and the rotor at ambient temperature. This clearance is not necessarily the clearance between the fingers and the rotor. From 0 to 1200 fps the radial interference increased from 0.0032 to 0.0098 in., a change of 0.0066 in., which exceeds the expected centrifugal growth of about 0.0033 in. This indicates that the seal holder and rotor are not maintaining the same temperature, which is supported by the approximately 200 °F change in the seal backface temperature during this initial rotation.

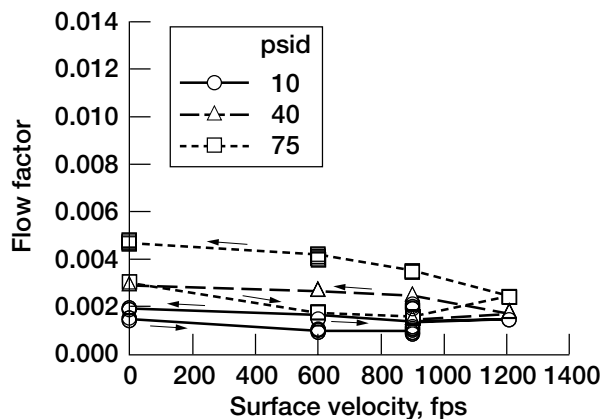
Figure 6.—Finger seal performance test data at 800 °F average seal inlet air temperature and 10, 40, and 75 psid pressure drop across seal.

Leakage. The finger seal leakage performance at average seal inlet air temperatures of 800 and 1200 °F is shown in figures 6 and 7, respectively, as plots of flow factor versus surface velocity at pressure drops across the seal of 10, 40, and 75 psid. At 800 °F it can be seen that the flow factor at 10 psid is less than at 40 and 75 psid. Also, the flow factor data at 10 psid and for increasing speed at 40 and 75 psid are about the same, approximately 0.0016 to 0.0018. Hysteresis can be seen in the data taken at 40 psid and at 75 psid and is more pronounced at 75 psid. When speed increases, the centrifugal growth of the rotor pushes the fingers radially away. When speed decreases and the rotor diameter shrinks, the fingers may remain in their outer position causing leakage and flow factor to increase. Hysteresis may also be due to rapid wear of the seal during initial shaft rotation, which would increase the seal clearance. Likewise, seal holder and rotor temperature

changes can affect the seal clearance and appear as hysteresis. However, even with the hysteresis the flow factor is still at an acceptable level of less than 0.006.

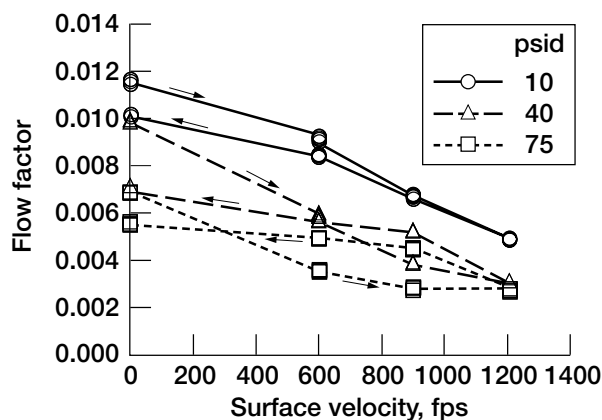
Figure 7.—Finger seal performance test data at 1200 °F average seal inlet air temperature and 10, 40, and 75 psid pressure drop across seal.

The flow factor for an average inlet air temperature of 1200 °F is shown in figure 7. At all three pressure differentials, the flow factor decreases as speed increases due to the centrifugal growth of the rotor reducing the clearance, as expected. Again, hysteresis is evident, but at 10 and 40 psid there is an inconsistency with previous data in that flow factor is lower for decreasing speed than for increasing speed. Also, as pressure drop across the seal increased, flow factor decreased, which is opposite to what happened at 800 °F. This can be explained by a look at the corresponding radial clearance data in figure 8. It shows that the radial clearance is lower for decreasing speed compared to increasing speed and that the radial clearance decreases as pressure drop across the seal increases. In this test sequence there is a clear and definite influence of changes in the radial clearance between the seal holder and the seal rotor. While data was taken at steady state conditions, the clearance between the seal holder and the rotor was not a controlled parameter. It seems that some of the hysteresis observed may actually be due to changes in the radial clearance between the seal holder and rotor and not due to the fingers getting stuck in the open position. The clearance data shown here indicates that a radial interference existed between the seal and rotor for most of the performance testing. By the end of the performance test the seal had worn such that a clearance existed between it and the rotor at ambient conditions.

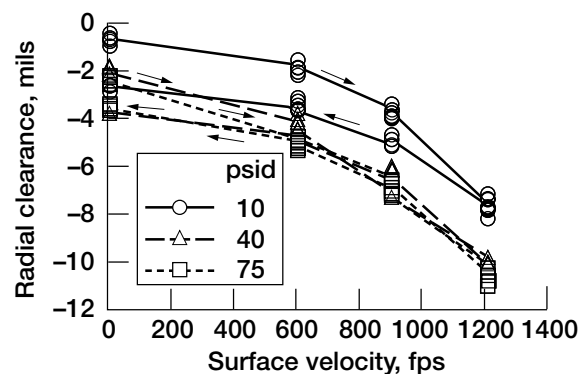
Figure 8.—Finger seal performance test radial clearance data at 1200 °F average seal inlet air temperature and 10, 40, and 75 psid pressure drop across seal.

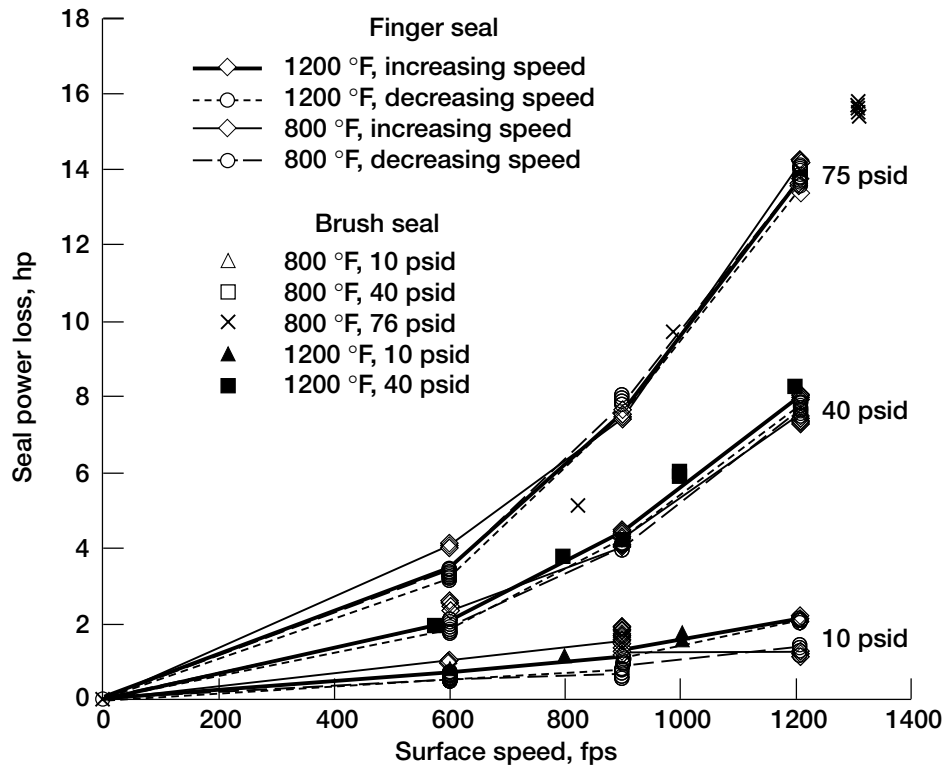
Figure 9.—Finger seal and brush seal power loss versus speed at 800 and 1200 °F average seal inlet air temperature and 10, 40, and 75 psid pressure drop across seal.

10, 40, and 75 psid. There is no significant difference between the data for 800 and 1200 °F. As expected, the seal power loss increased with speed and also increased as pressure drop across the seal increased due to pressure loading. Pressure loading occurs because the outer surface of the finger is longer than the inner surface, which under uniform pressure results in a net force pushing the fingers in towards the rotor. While the upstream finger element experiences uniform pressure loading, the pressure loading on the middle and downstream finger elements is not precisely known. The finger seal power loss at 1200 fps was 2, 8, and 14 hp at 10, 40, and 75 psid across the seal, respectively. The measured power loss was in good agreement with analytical predictions made by Honeywell using a proprietary code. A brush seal with a similar radial interference as this finger seal was also tested and its measured power loss is also shown in figure 9. The brush seal power loss is very similar to the finger seal power loss.

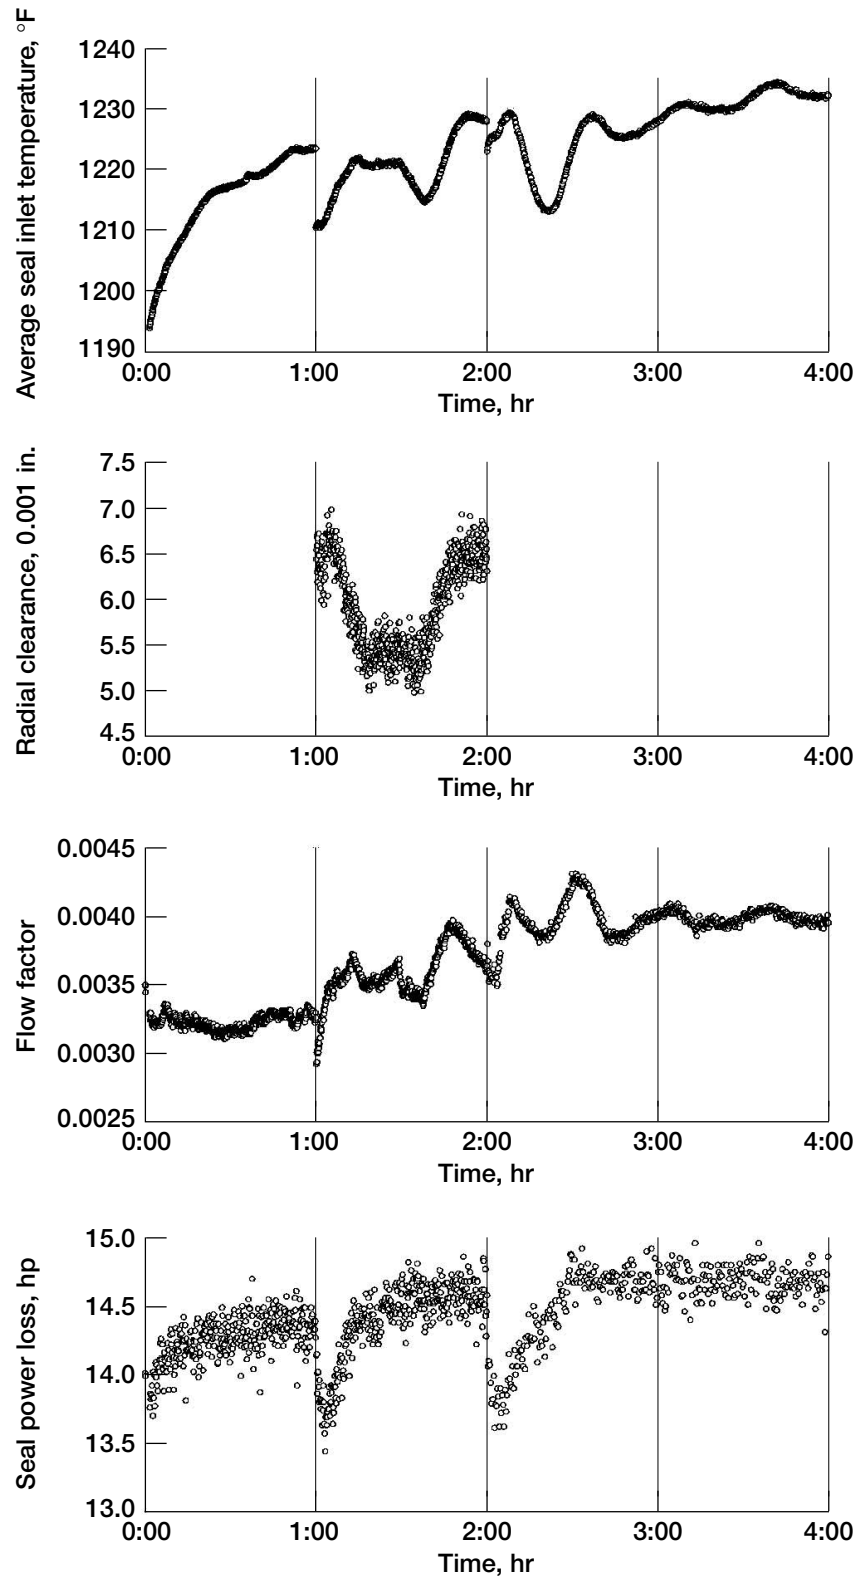
Figure 10.—Time history of finger seal endurance test at 1200 °F average seal inlet air temperature, 1200 fps surface speed, and 75 psid pressure drop across seal.

The time history of key parameters for the endurance test is shown in figure 10. Surface speed and pressure drop across the seal are very stable over the run: 1200 ± 0.5 fps and 75 ± 0.09 psid. There is some small fluctuation in the flow factor, average inlet air temperature, and radial

clearance, and they correlate with each other. Seal power loss initially climbs and then levels out. The minimal change in flow factor over the duration of the mini-endurance test indicates that most of the wear of the seal occurred during the prior performance test. The final flow factor level of 0.004 is an acceptable leakage performance. It was also observed that the inlet air temperatures measured at three locations around the seal showed a more uniform temperature around the seal than during the performance test. In the endurance test the seal inlet temperature at the top of the rig was about 50 °F lower than at the 120 and 240° locations, compared to 100 to 150 °F for the performance test. This was largely due to the long period of time at constant conditions.

Figure 10 shows a flow factor of approximately 0.004 at 1200 °F, 75 psid, and 1200 fps after 4 hours of endurance testing. This is very similar to the low leakage results for a 5.1 in. diameter pressure-balanced finger seal design tested at 1000 °F, 60 psid, and 778 fps in reference 4.

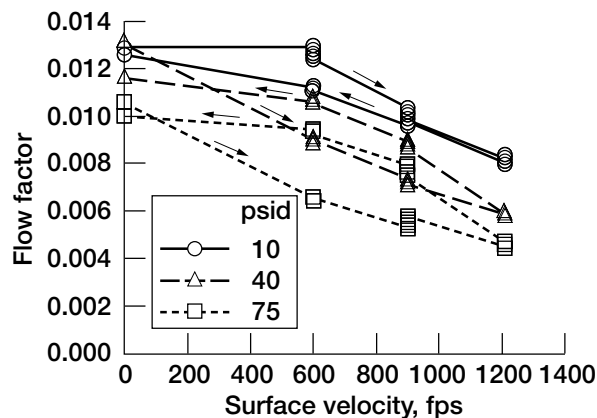
Figure 11.—Post-endurance performance test. Finger seal flow factor versus speed at 1200 °F average seal inlet air temperature and 10, 40, and 75 psid pressure drop across seal.

The flow factors measured at an average inlet air temperature of 1200 °F are shown as a function of speed at pressure differentials of 10, 40, and 75 psid in figure 11. The flow factors ranged from 0.0045 to 0.013, which exceeds the goal of 0.006, but are still acceptable. The hysteresis is somewhat worse in this last performance test than in the first performance test. As seen in the first 1200 °F performance test, the hysteresis is reversed at 10 psid with the flow factor for decreasing speed being lower than for increasing speed. This is likely due to changes in the radial clearance, however the proximity probes stopped working during this test and the data is not available to confirm the effect.

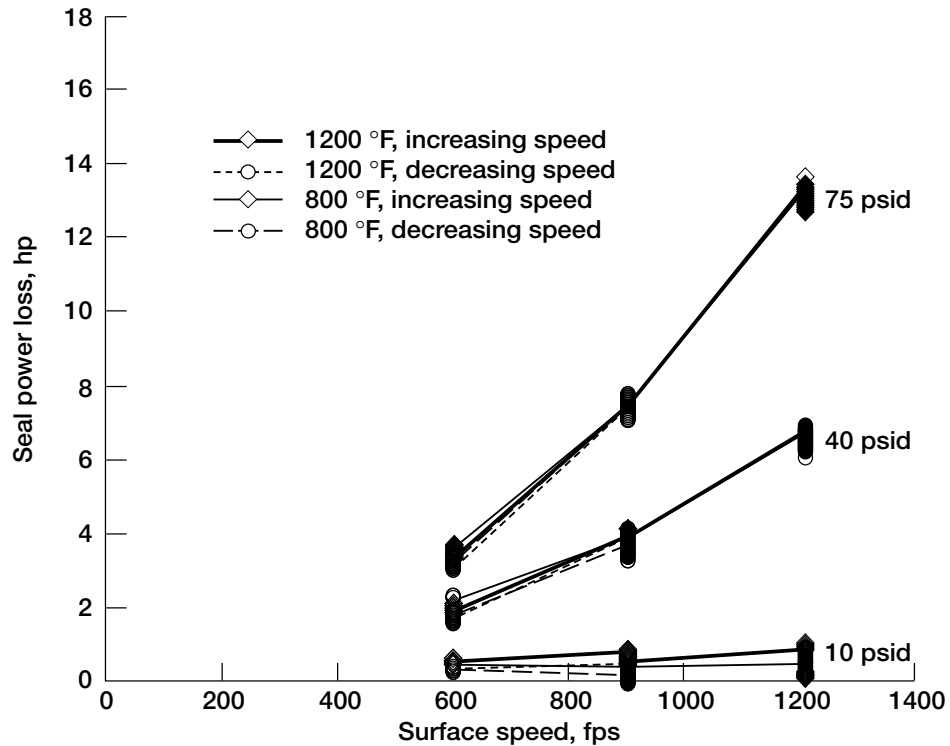
Figure 12.—Post-endurance performance test. Finger seal power loss versus speed at 1200 °F average seal inlet air temperature and 10, 40, and 75 psid pressure drop across seal.

The finger seal power loss measured during the post-endurance performance test is slightly less and very comparable to the measurements made in the first performance test as can be seen by comparing figure 12 to figure 9, respectively.

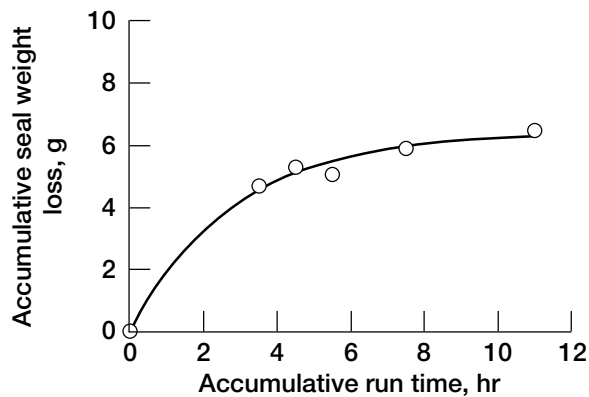
Figure 13.—Finger seal accumulative weight loss versus accumulative run time.

Figure 13 is a plot of the accumulated seal weight loss after the first performance test (3.5 hr), 1st, 2nd, and 4th hour of endurance testing, and final performance test (11.0 hr). Over 70 percent of the total seal weight loss occurred during the first performance test. The remaining 30 percent was spread out in the remaining endurance and final performance tests. The seal weight loss appears to converge asymptotically toward a steady state value. Assuming that this weight loss occurred uniformly around the circumference of the seal, the radial wear is calculated to be about 0.035 in., or slightly more than half the finger pad thickness.

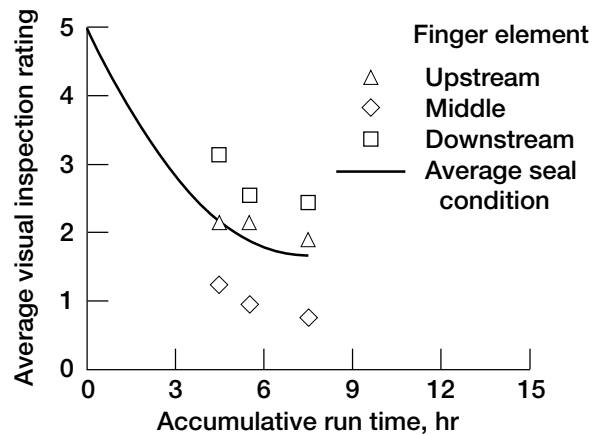
Figure 14.—Average visual inspection rating of finger seal wear versus accumulative run time for upstream, middle, and downstream finger elements.

The visual inspection of the individual finger pads also suggests that minimal seal weight loss occurred after the first performance test. All 64 pads on each of the 3 laminates were given a qualitative rating (0 to 5 scale) based upon the amount of radial wear seen. For example, a '5' was given if the pad showed very little wear. A '3' was given for pads showing approximately 50 percent radial wear. A '1' was given if the pad toe was worn to a point. The 64 individual pad ratings were averaged to give an overall rating for each laminate. Figure 14 shows the averaged visual laminate wear rating for the 3 laminates of the finger seal after 1, 2, and 4 hours of endurance testing. The average laminate wear rate for each laminate decreases asymptotically to a steady-state value. Note that the middle

Visual inspection rating definitions	
5	= 0% average pad wear
4	= 25% average pad wear
3	= 50% average pad wear
2	= 75% average pad wear
1	= 100% average pad wear
0	= No pad

laminate was observed to have the worst overall wear of the 3 laminates. The qualitative visual inspection ratings correspond reasonably well with the radial wear calculated from the weight loss.

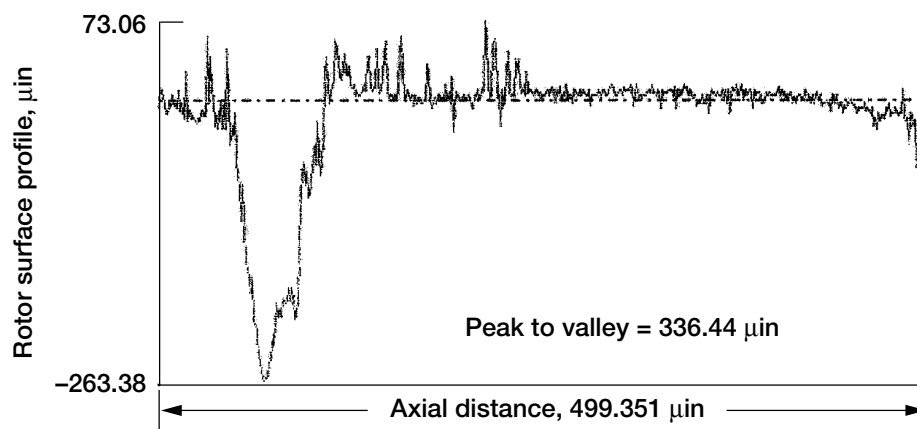
Figure 15.—Typical profile of seal wear track on rotor outer diameter.

Rotor wear was quantified using a profilometer. A typical profile of the wear track is shown in figure 15. Eight measurements were taken around the circumference of the rotor to determine an average track width and depth. These averages are presented in table II for each inspection. Both the track width and track depth measurements indicate that the majority of the seal wear took place during the first performance test. The average track width ranged from 0.080 to 0.100 in. and the average track depth ranged from 150 to 250 μin. This is a small and acceptable amount of
